NASA Contractor Report 172359

## ACEE COMPOSITE STRUCTURES TECHNOLOGY

Papers by  
Douglas Aircraft Company

DAMAGE TOLERANCE AND FAIL-SAFE TESTING  
OF THE  
DC-10 COMPOSITE VERTICAL STABILIZER  
CONTRACT NAS1-14869

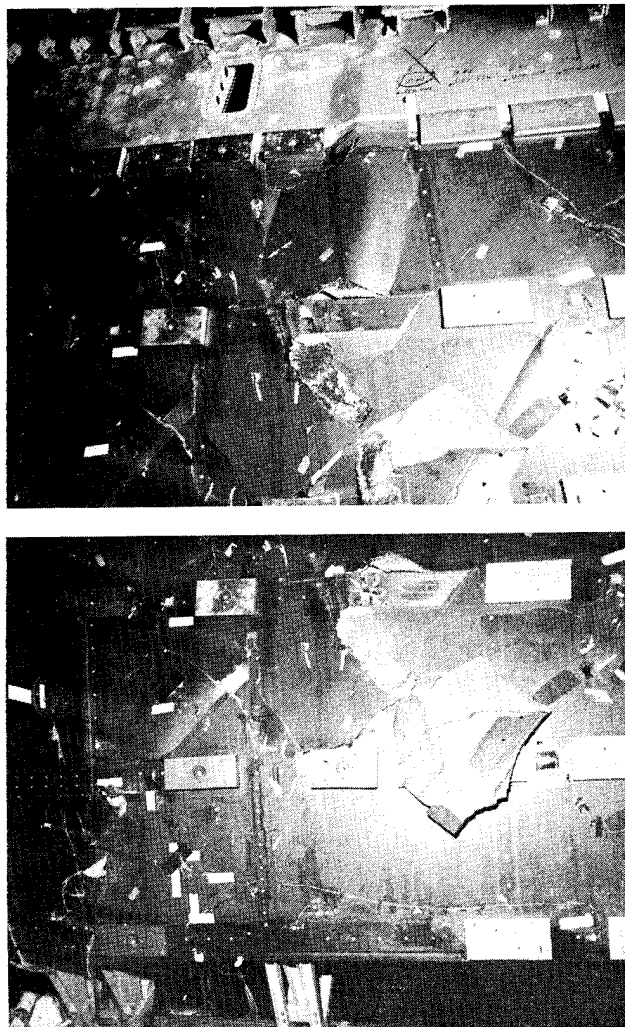
FIGURE 23.

In the test, loads simulating the critical bending condition were applied to the test article in a direction that placed the left side in compression. The loads were applied continuously to failure at a constant rate of approximately 1 percent of design limit load per second. Failure occurred in the left skin panel at 167 percent of design limit load. The skin panel spar cap material failed in compression, initiating at  $Z_{FR}$  station 329 (Figure 23). No failures were evident in the two repaired areas or in any of the rear spar access cover installations.
